#### UNITED STATES ENVIRONMENTAL PROTECTION AGENCY

ACTION MEMORANDUM - Request for a Time-Critical Removal Action at the

Plate-Rite Plating Site, Dayton, Montgomery County, Ohio (Site ID #B5YL)

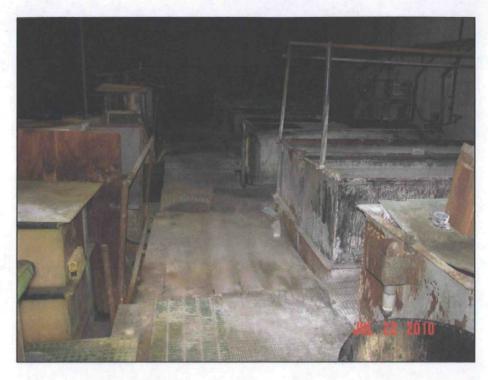
View of abandoned plating vats

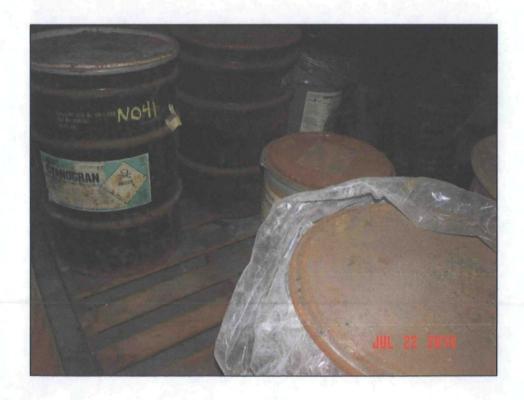
View of drums containing cyanide

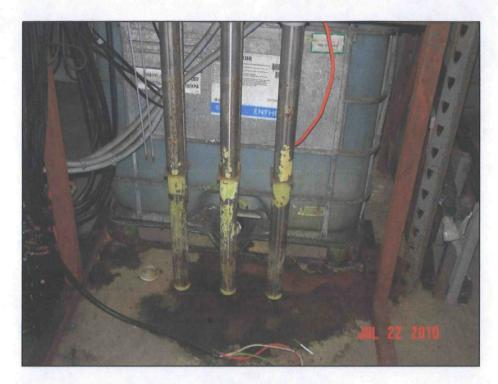
View of a leaking container

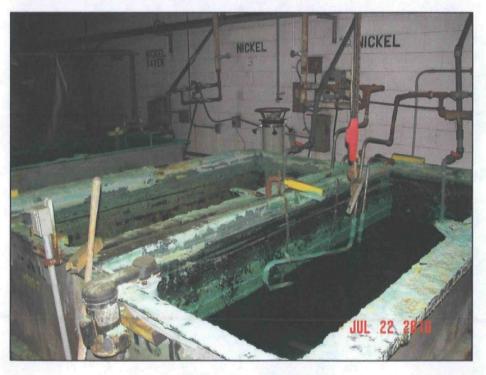
View of abandoned plating vats

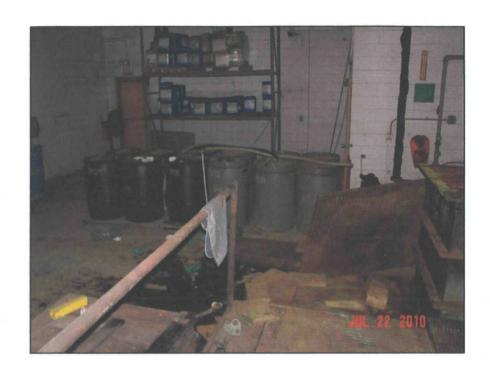
View of abandoned drums and containers

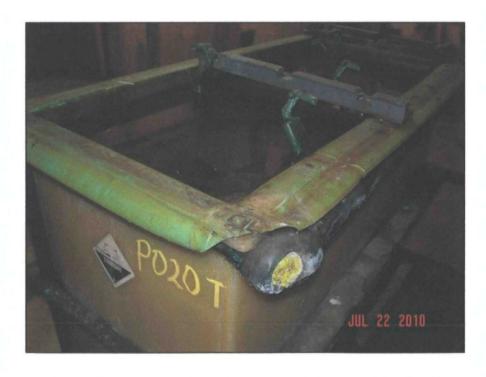
View of an abandoned plating vat containing corrosive liquid
